## **Comparative study on submillimeter flaws in stitched T-joint carbon fiber reinforced polymer by infrared thermography, microcomputed tomography, ultrasonic c-scan and microscopic inspection**

Hai Zhang  
Ulf Hassler  
Marc Genest  
Henrique Fernandes  
Francois Robitaille  
Clemente Ibarra-Castanedo  
Simon Joncas  
Xavier Maldague

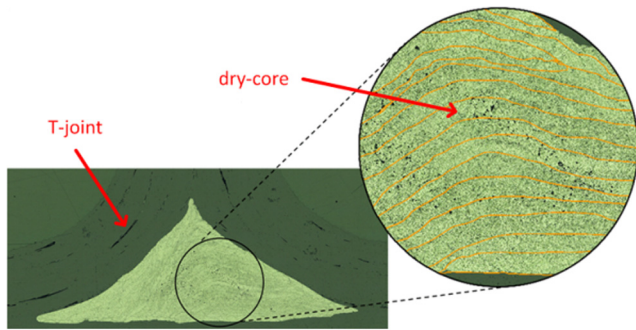
technique has the potential of creating a low-cost T-joint with improved damage tolerance and failure strength.<sup>4</sup> However, incomplete infusion of T-joints core (dry-core) is an essential issue. Figure 1 shows a typical dry-core in a nonstitched 3-D T-joint CFRP.

**Fig. 1** A typical dry-core in a nonstitched three-dimensional (3-D) carbon fiber-reinforced polymer (CFRP) (microscopic inspection).

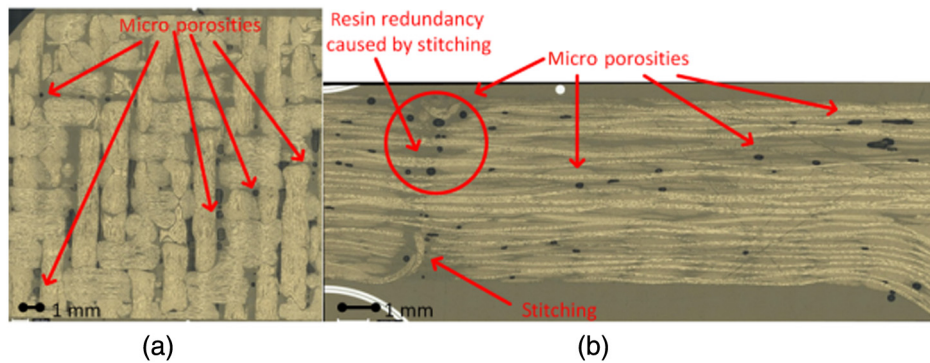
The microscopic inspection results are shown in Fig. 3. Figure 3(a) shows the microporosities in the top section. Figure 3(b) shows the stitching and microporosities in cross section. In Fig. 3(b), more microporosities in the resin redundancy zone are inspected than in other zones. Most microporosities measure a diameter of about  $0.1\text{ mm}$  to  $0.2\text{ mm}$ , as shown in Fig. 3.

**Fig. 3** Microscopic inspection results: (a) top section and (b) cross section.

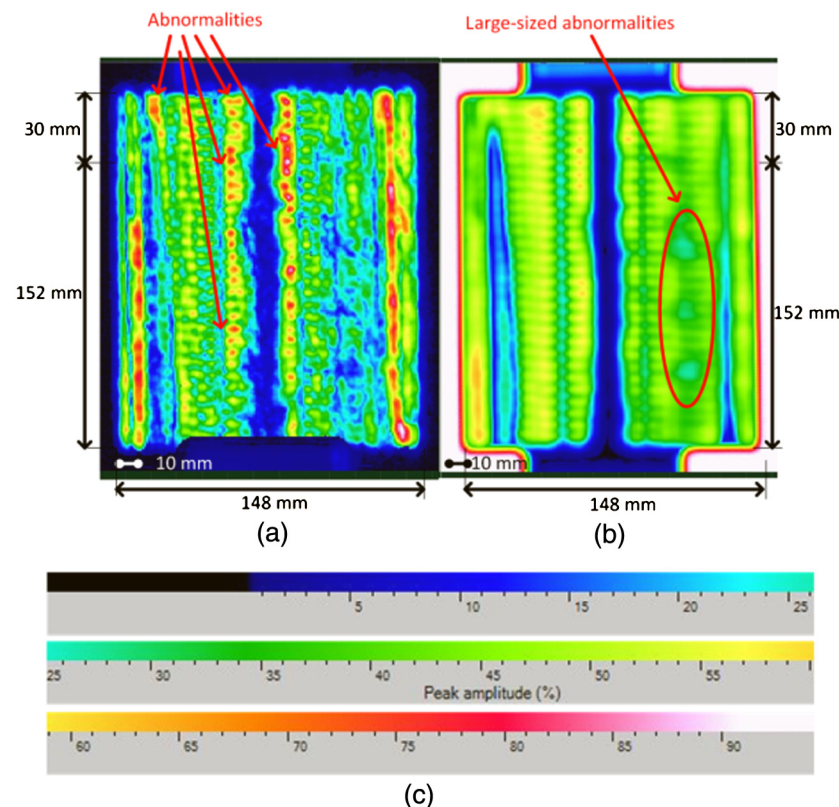
In Fig. 4(a), many abnormalities are detected. Some of them might be voids and porosities. However, it is a challenge to identify and characterize them due to the attenuation and scattering of the ultrasonic beams, which are caused by the complex internal structure. In Fig. 4(b), three large-sized abnormalities are shown. They might be resin abnormalities

or internal structural flaws. However, they are also difficult to identify and accurately characterize. Ultrasonic c-scan using transducers with frequencies of 5, 10, and 15 MHz was also performed. However, none of the scans can identify and accurately characterize the internal flaws.

**Fig. 4** Ultrasonic c-scan results (2.25 MHz): (a) pulsed-echo, (b) through-transmission, and (c) color scale for signal amplitude percentage.

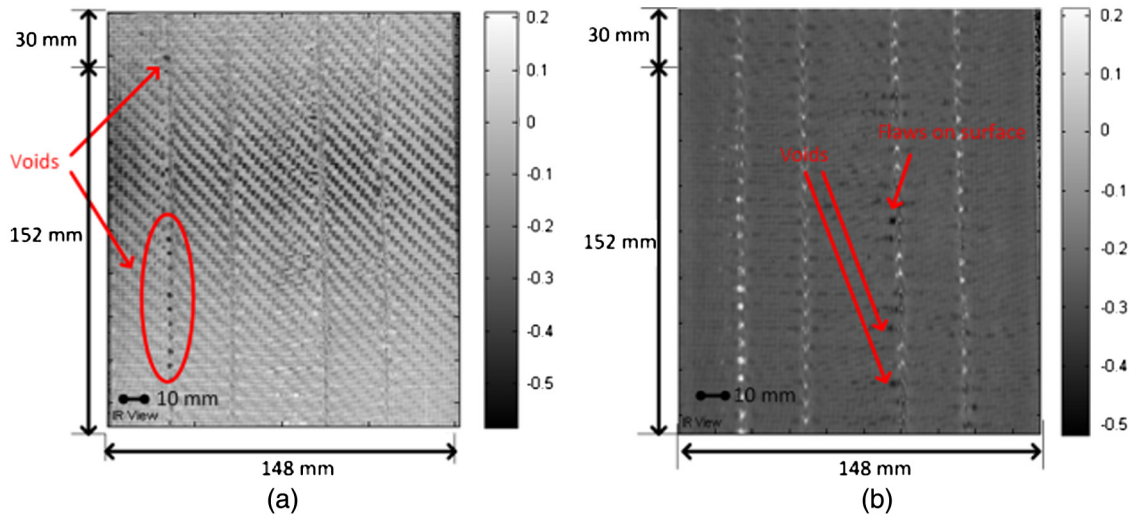
Figure 6 shows the detection results before the microscopic inspection. Figure 6(a) shows the image from first derivative image processing. Figure 6(b) shows the image from second derivative image processing. In Fig. 6, some voids measured around 1 to 2 mm are inspected. Pulsed thermography can detect large-sized flaws. However, it is a challenge to characterize submillimeter flaws. Several image

processing methods were conducted. However, none of them can identify and characterize submillimeter flaws.

Fig. 6 Pulsed thermography results: (a) first derivative and (b) second derivative.

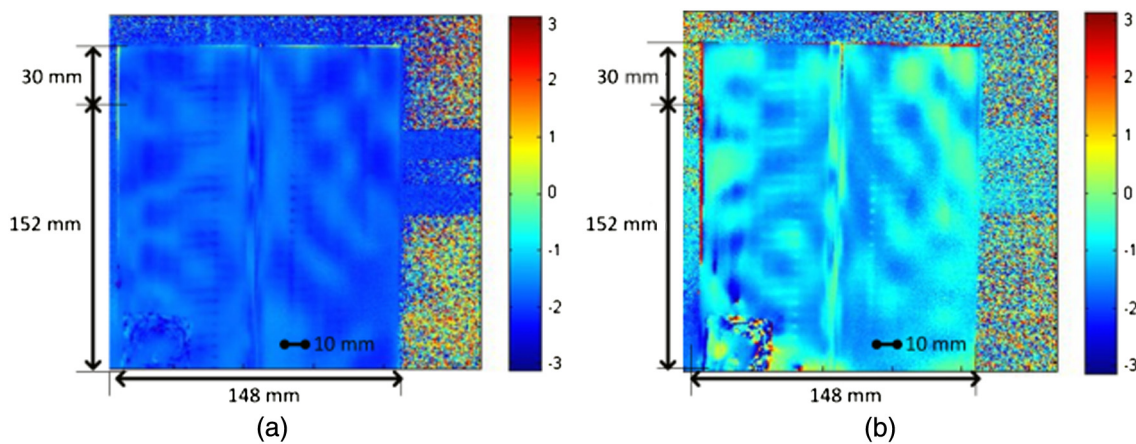
Figure 8 shows the detection results before the microscopic inspection. None of the two images can identify flaws. The potential reason is heat source coupling caused by the complex internal structure.

Fig. 8 Vibrothermography results.

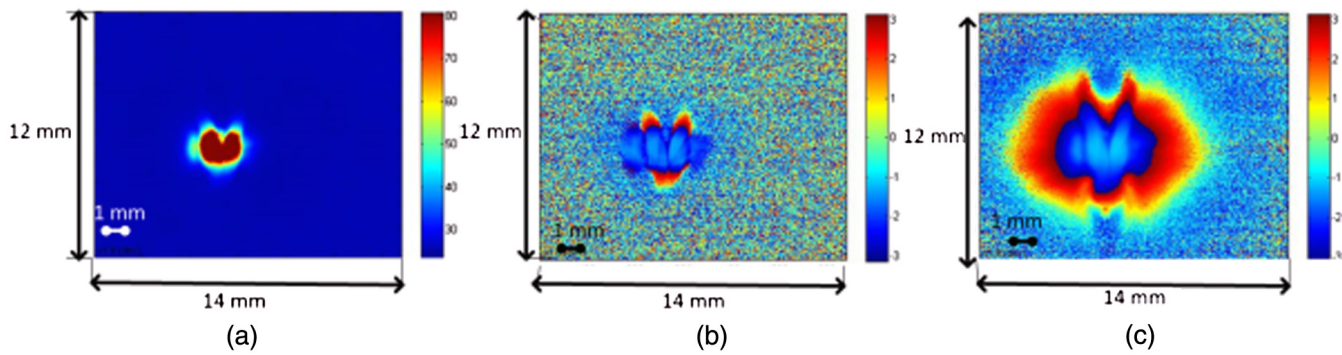
Fig. 11 Laser spot thermography results (locked-in method): (a) surface, (b) depth: 0.21 mm, and (c) depth: 0.65 mm.

and Figure 11(c) shows the result from the depth of 0.65 mm. The detected depths were calculated using Eq. (4). In Fig. 11, no defect is detected. Laser spot thermography can detect internal structure and flaws using the lock-in method. However, it is a time-consuming technique. It is difficult to detect the entire sample (152 mm  $\times$  148 mm) using laser spot thermography.

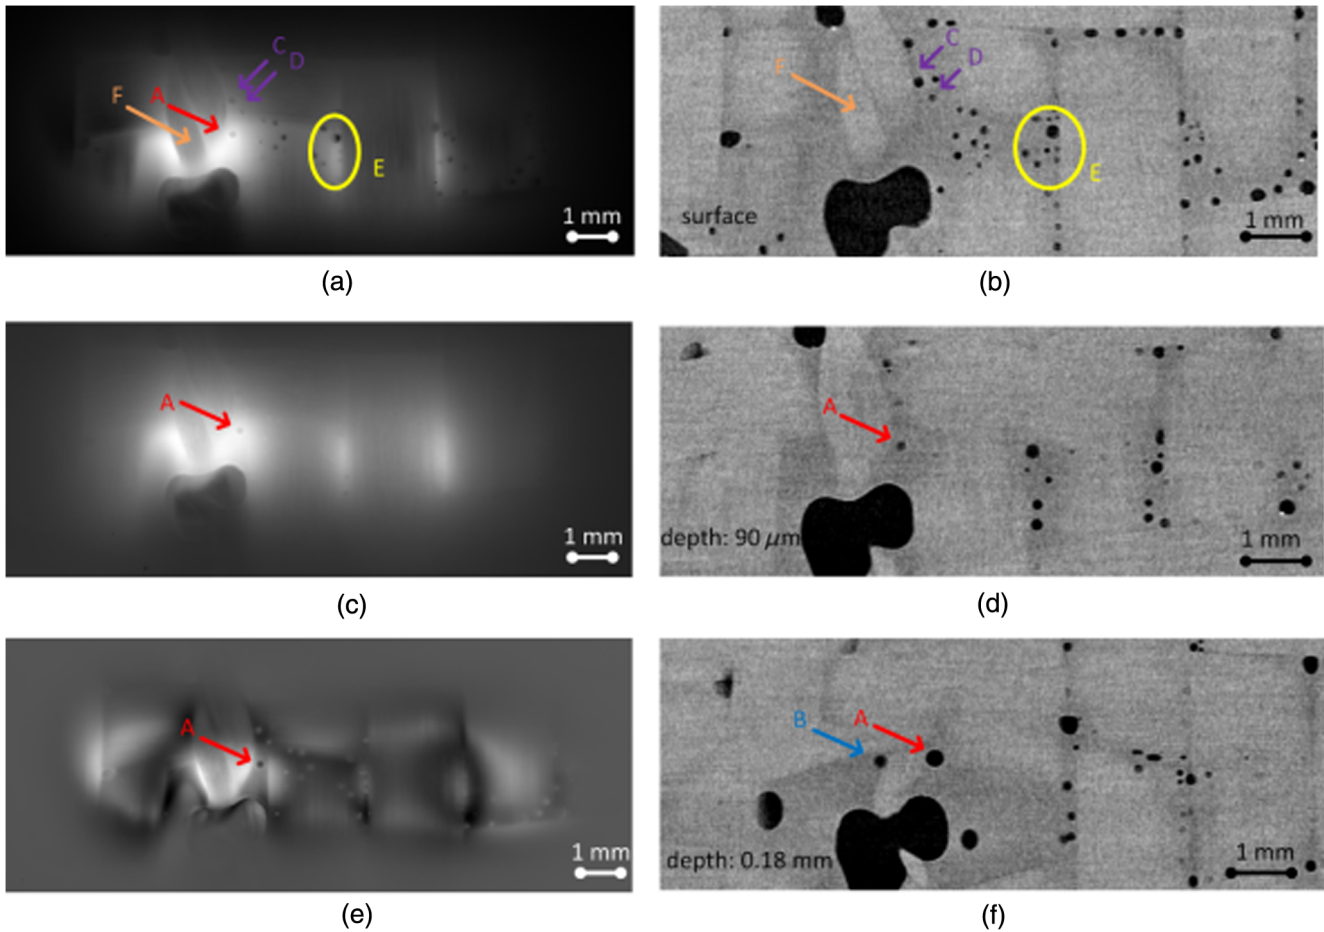
Figure 13 shows the comparison of microlaser line thermography results and high-resolution x-ray tomography results. Some specific microporosities are marked in the images. Figure 13(b) shows the surface image of a detected zone. The image was acquired using 18- $\mu$ m resolution x-ray tomography. Some microporosities are detected on the surface. Figure 13(a) shows the microlaser line thermography image in the same zone. The infrared image was from cold image subtraction. This image processing method is used to reduce the effects of fixed artifacts in a thermographic sequence, for example, reflections from the environment such as residual heating coming from the lamps and even the reflection from the camera that appears during the acquisition. Since these artifacts are more or less constant during the whole acquisition, including before heating when the image is “cold,” this image or the average of several

**Fig. 13** (a) Microlaser line thermography result (cold image), (b) x-ray tomography result (surface), (c) microlaser line thermography result (contrast rectification), (d) x-ray tomography result (depth: 90  $\mu\text{m}$ ), (e) microlaser line thermography result (PCT), and (f) x-ray tomography result (depth: 0.18 mm).

images can be subtracted before heating, so their effect is reduced. In Fig. 13(a), some microporosities on the surface such as C and D (marked in purple) are detected. However, some other microporosities on the surface such as some in the zone E (marked in yellow) are not detected. The potential

cause is the infrared camera resolution limitation. The microporosities with a diameter of less than 54  $\mu\text{m}$  cannot be detected in Fig. 13(a).

In Fig. 13(a), the microporosity A (marked in red) is detected. However, it is not detected on the surface shown

in Fig. 13(b). It appears from the depth of 90  $\mu\text{m}$  shown in Fig. 13(d). Figure 13(d) shows the x-ray tomography image from the depth of 90  $\mu\text{m}$ . The microporosity A measures 0.162 mm in diameter. The microporosity A can be detected more clearly in the infrared image with the contrast rectification shown in Fig. 13(c). Figure 13(e) shows the infrared image from principal component thermography.<sup>30</sup> In Fig. 13(e), the performance of the microporosity A is exceptional (darker in contrast) compared to the other microporosities. These results confirm that microlaser line thermography can detect the internal submillimeter defects in the sample. However, the depth and the size of defects can affect the detection results.

Figure 13(f) shows the x-ray tomography image from 0.18 mm depth. The microporosity A measures 0.306 mm in diameter from 0.18 mm depth. The microporosity B (marked in blue) is detected. It measures 0.216 mm in diameter from a depth of 0.18 mm. However, the microporosity B cannot be detected in the infrared images. One potential cause is that the depth of 0.18 mm exceeds the IR camera detection limitation with the laser power of 2.9 W. Another potential cause is that the microporosity B is below the fiber F (marked in orange) shown in Figs. 13(a) and 13(b). This might reduce the heat diffusion. A finite-element simulation could be contributive to the analysis.
